2006-2643: FIVE MILES IN FORTY-FIVE DAYS - REBUILDING THE I-10 TWIN SPANS

John Ryan, SE/ES, LLC

5 miles in 45 Days – Rebuilding the I-10 Twin Spans

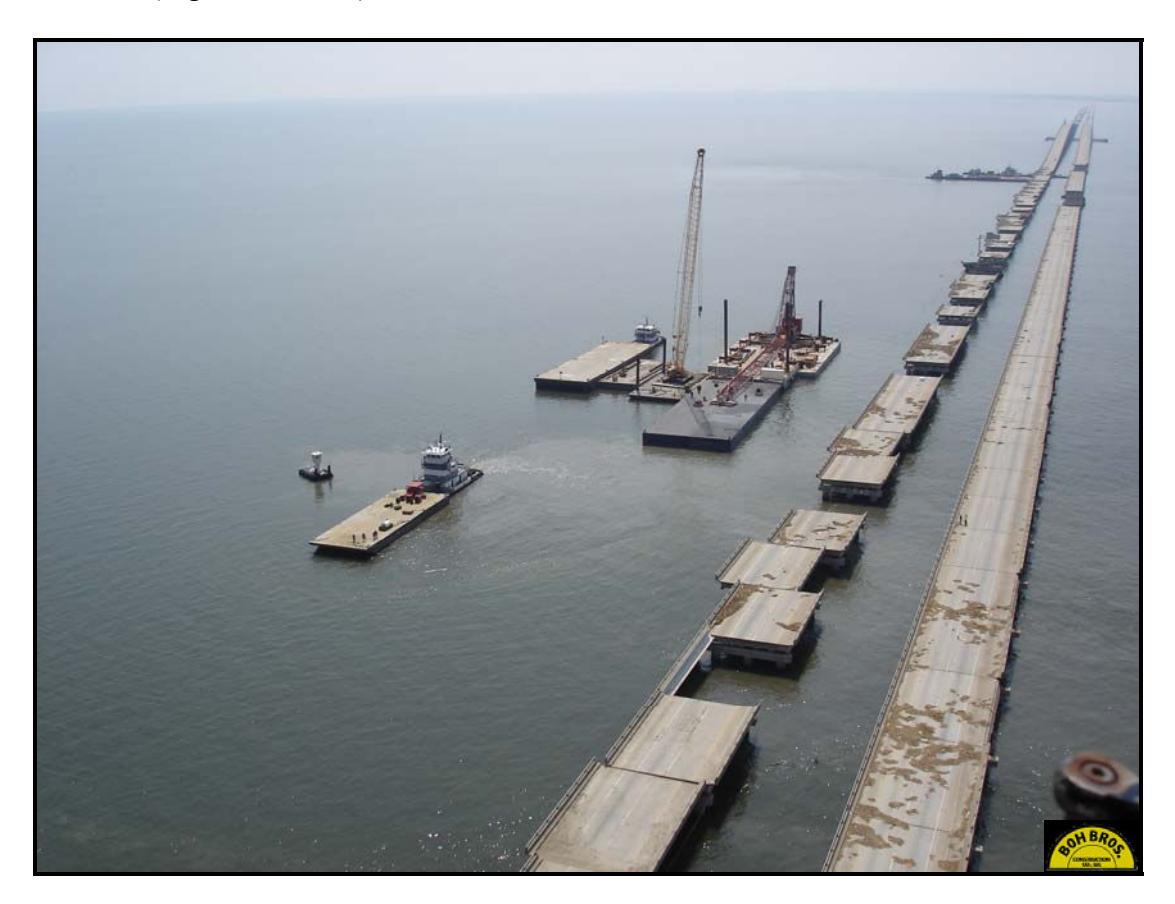
Figure 1: I-10 Bridge Damage

by large surf from eastern Louisiana to western Florida, and a coastal storm surge, later measured over 15.5 ft near Pass Christian, Mississippi, was fast approaching. As Katrina made land fall near Barataria Bay, Louisiana, it weakened to a category three hurricane, with maximum sustained winds of 125 mph. With storm surge gathering just to the north of the mouth of the Mississippi River, and category three easterly winds driving the massive volume of water into Lake Pontchartrain through the Mississippi Sound and Lake Bourne, wind-speed would quickly become a secondary concern for south-east Louisiana. Lake Pontchartrain filled with water from the Gulf of Mexico that would eventually be thrust through the south-shore levies and into sub-sea level areas of New Orleans East. The massive influx of water into Lake Pontchartrain caused the water level to rise as high as 15-20 feet above normal lake levels. The sudden rise in the lake was particularly devastating to the double-span US Interstate 10 Bridge (Twin Spans), which crosses Lake Pontchartrain at its narrowest point. As a result, nearly 40% of the simplespan, pre-cast girder and deck segments of the east-bound and west-bound bridges were damaged. The damage to the bridge decks ranged from shifting to complete removal of spans (Figure 1). The local area was devastated, evacuated, and temporarily nonfunctional (Figures 2 and 3).

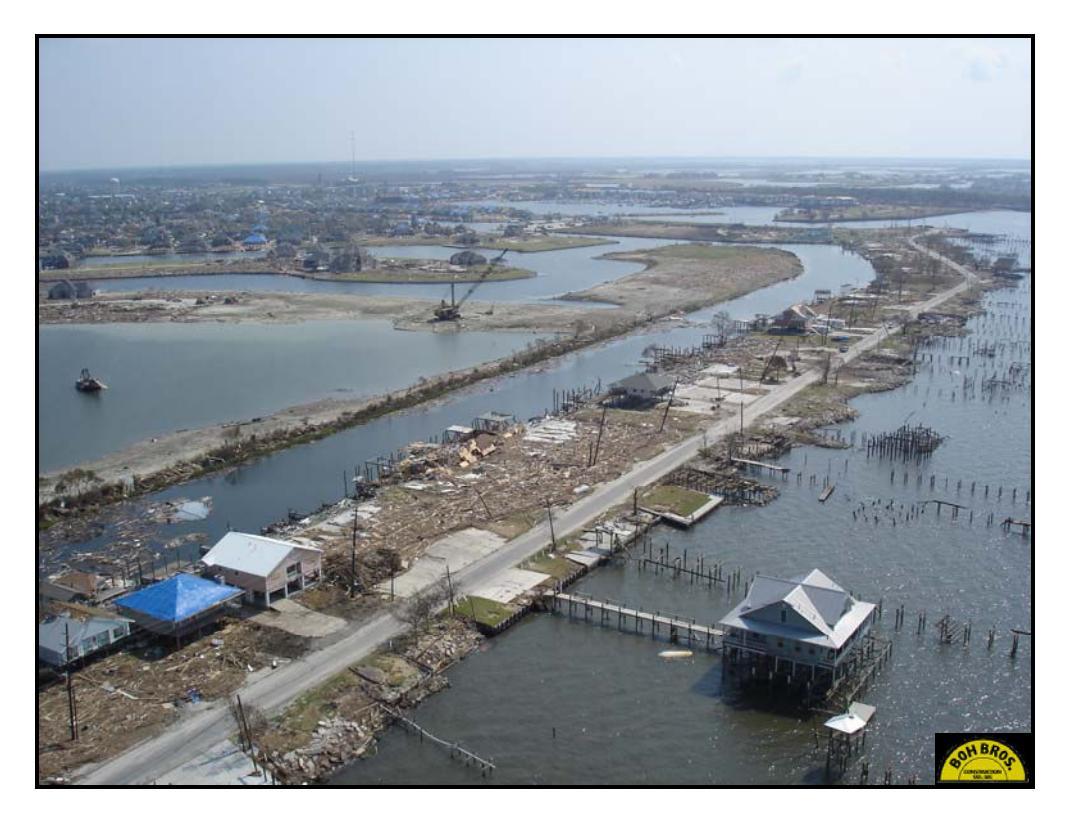
Figure 2: Infrastructure Damage – North Shore of Lake Pontchartrain

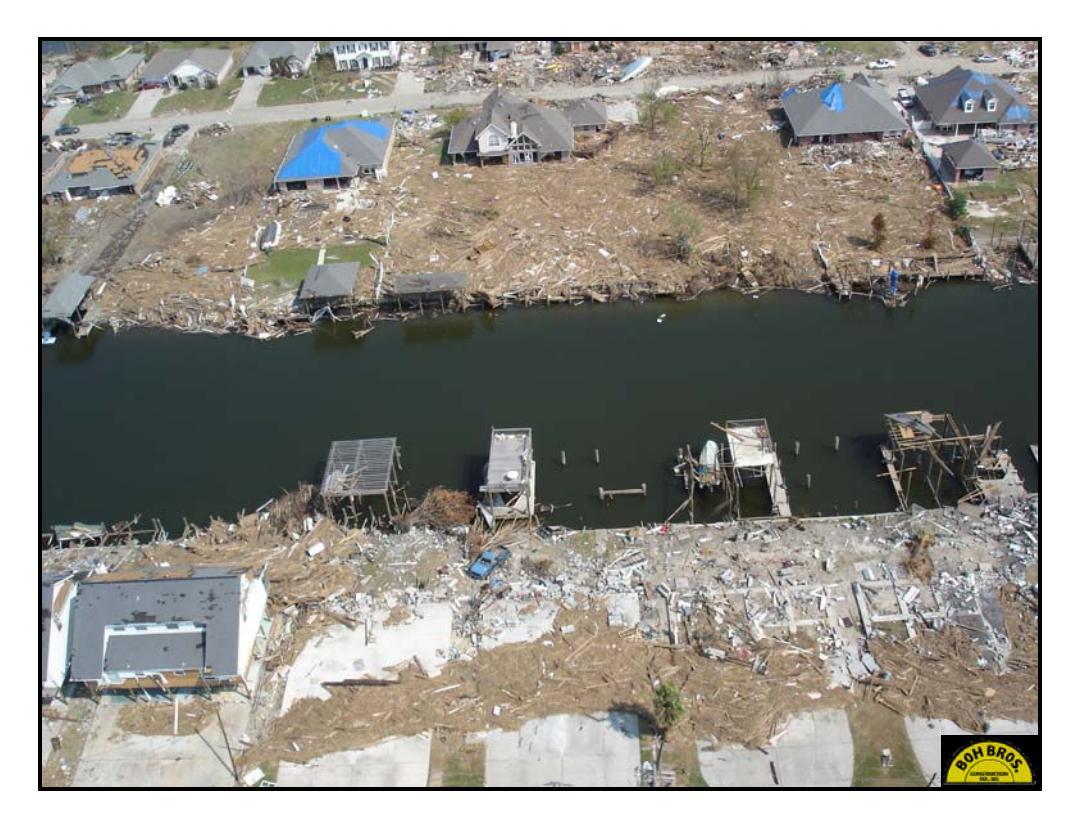
Figure 3: Infrastructure Damage – North Shore of Lake Pontchartrain

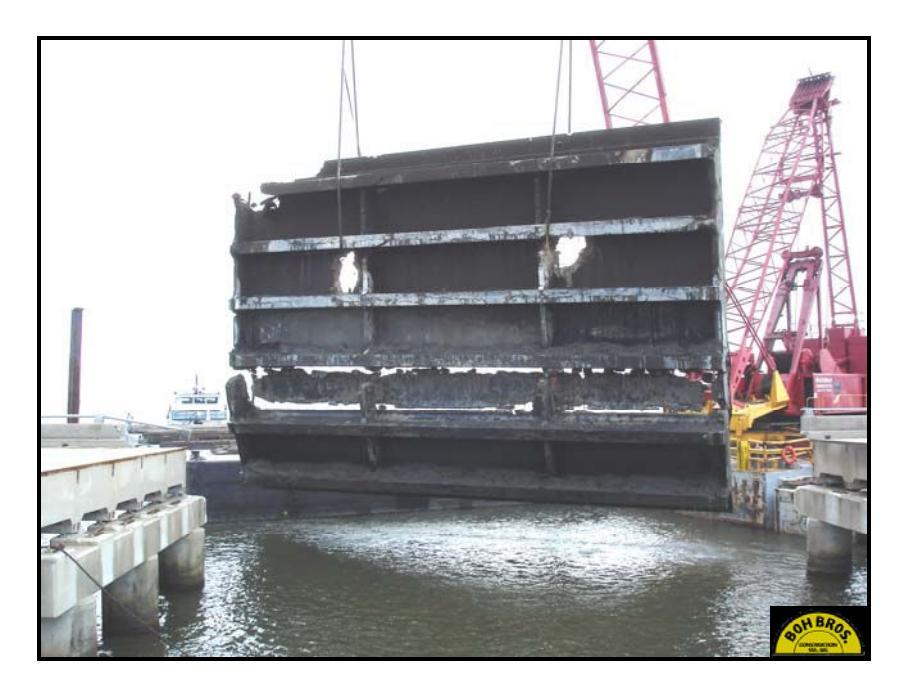
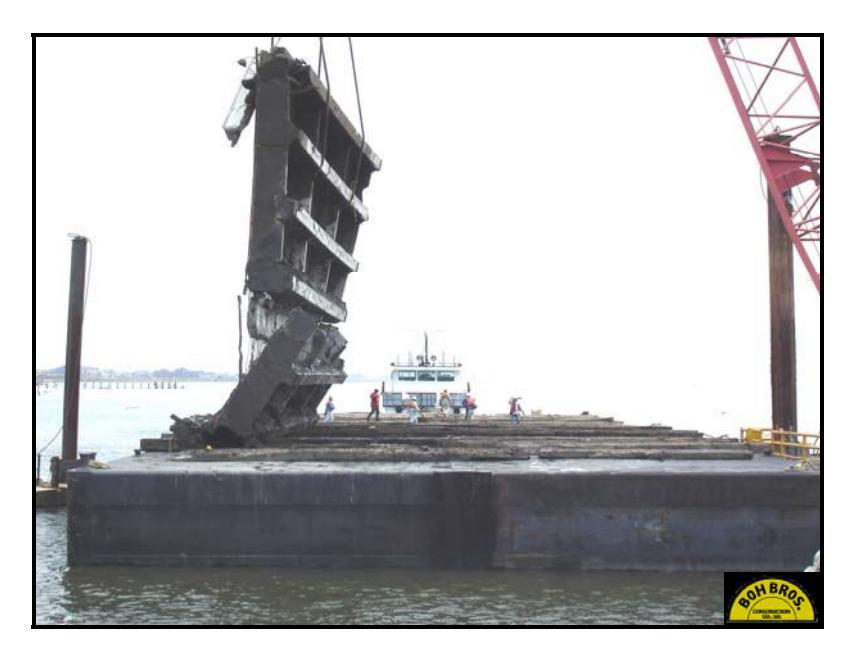
Figure 4: Submerged Deck Removal

Figure 5: Submerged Deck Removal

During the storm 39 deck sections were completely removed from the east-bound bridge and deposited in the lake adjacent to the bridge. The lake level near the bridge is between 8 and 12 feet, with a deeper channel dredged through a single high clearance bridge section located approximately one mile from the north approach. The barges used to support cranes, pile drivers, and trailers drafted between 4 ft and 8 ft of water, and tugs driving the barges drafted approximately 9 ft of water. To position the construction barges properly, submerged decks had to be located and removed prior to commencing repair operations. The removal operation was labor intensive both in and out of the water. Divers were used to locate bridge sections. Once a bridge section was located, holes in the deck (pick-points) were punched to allow for passage of slings and rigging, using an excavator-mounted hydraulic ram. Because the decks were heavily damaged, the location of the pick-points needed to be carefully selected to ensure a stable lift. Audio communication with divers was the only means of locating the position of the divers in the water. The inability to visually locate the divers in 8 to 12 feet of water from the surface created a hazard to the divers as they guided the hydraulic ram. Being pinned by barges drafting all but two feet of available water depth or seriously injured by the hydraulic hammer in the murky water were two primary hazards. After successfully rigging a deck, the work was only halfway complete. Lifting the 285-ton deck sections required the use of a Manitowoc 4600 crane with ringer attachment and a 200-ft. boom. Heavy marine lifting in the best conditions requires careful evaluation and risk management of wave action and wind conditions. In this case, the stability of the load presented a significant additional risk. Loss of deck material during the lift caused instantaneous load shifts and rupture of material being bent and then put into direct tension as the sections were being lifted (Figures 4 and 5). The result was shock loading to the crane. After removing approximately 60% of the submerged deck sections, permission to break up the remaining submerged deck sections and drive the rubble into the lake bottom was granted by the State of Louisiana. Although the objective to seeking this allowance was based primarily on safety, it resulted in a much more efficient method

of clearing debris adjacent to the bridge. Since debris removal was a critical path item, the early completion of Phase I can be attributed, in part, to the alternative method used.

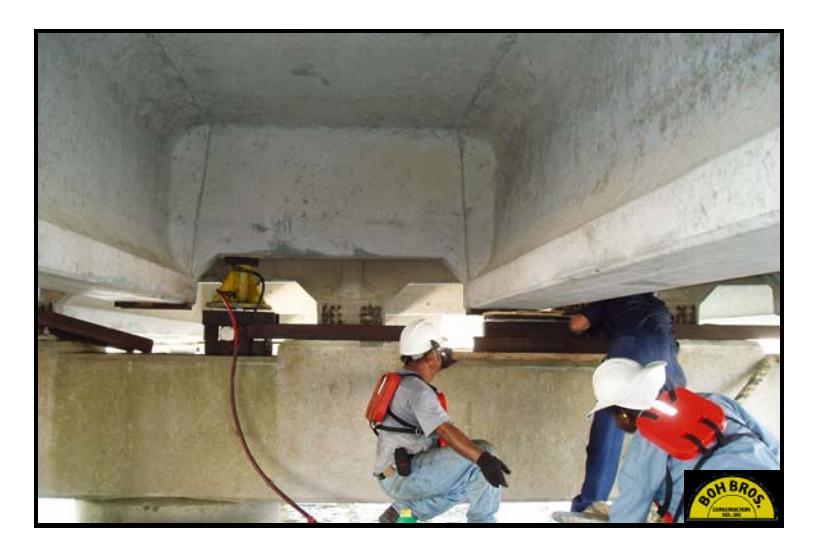
Figure 6: Vertical Jacking of Deck on to Teflon Slide Plates

to the east-bound span began. The first method of re-aligning deck sections consisted of jacking a deck vertically onto Teflon slide plates between pile caps and girders, and jacking the decks horizontally back to their original bearing pad locations (Figure 6). Horizontal jacking was accomplished by positioning hydraulic pipe jacks at an angle between the curb of properly aligned deck segments and the curb of deck segments to be moved (Figure 7). Positioning the slide plates required the use of a barge beneath the bridge. However, horizontal jacking was done on the top side of the bridge and did not require the use of a barge during jacking operations. A relatively light demand for barge support and independence from wave action resulted in a very efficient method of realignment and was utilized for deck sections requiring re-alignment of five feet or less.

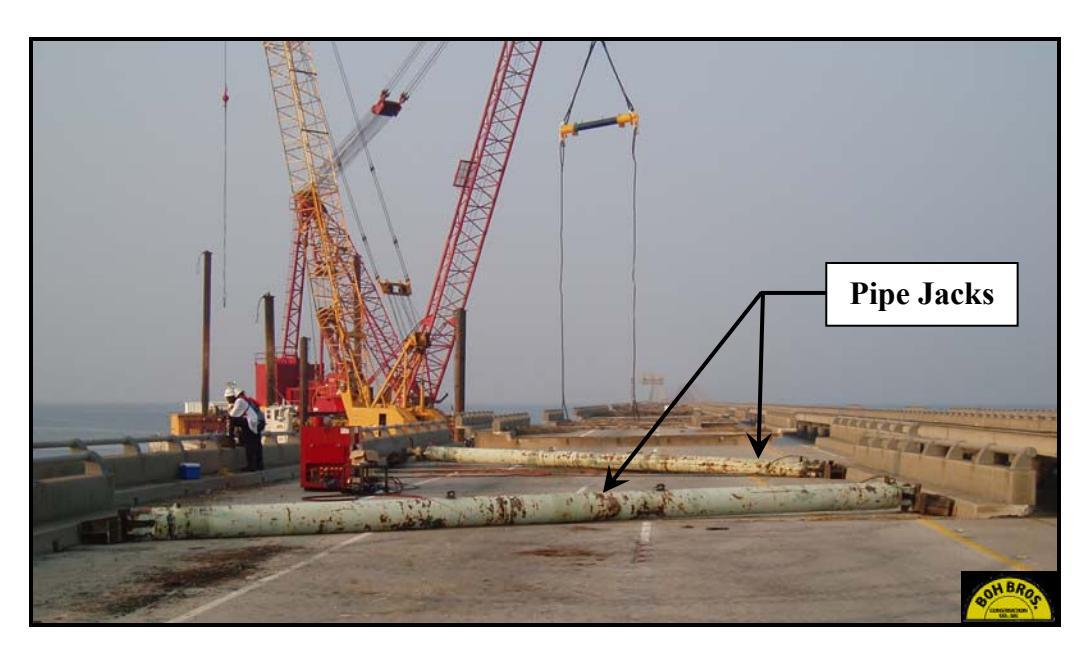
Figure 7: Horizontal Re-alignment Jacking

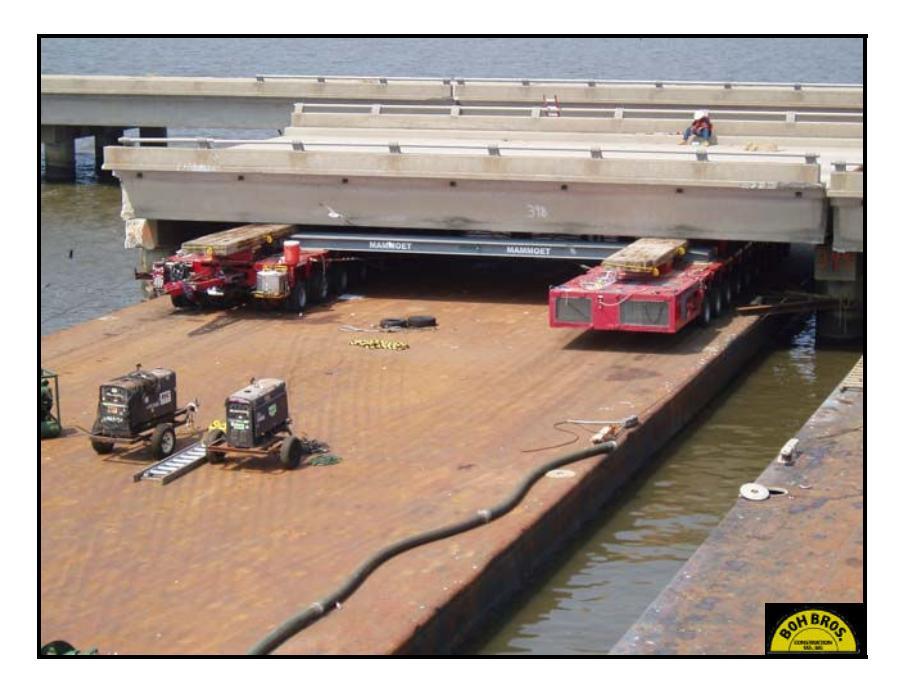
Figure 8: Tri-directionally Adjustable Barge Mounted Trailers

For deck sections which were out of alignment by more than five feet, barges were used for support. An innovative trailer system on top of the barges was also utilized, which greatly increased efficiency. Similar bridge repair operations in the past consisted of providing a fixed support for a deck section on a barge deck. Moving and placing the deck segment precisely onto the bearings could then be accomplished by adjusting the location of barge. This process requires constant adjustment for lateral movements of the barge due to current, as well as vertical wave action, and is extremely time-intensive. To save time, a new concept was conceived by Boh planners. The apparatus for the concept consisted of a tri-directionally adjustable, barge-mounted trailer system (Figure 8). With the deck section jacked high enough to clear the bearings, a barge was moved to a suitable location in the bent where re-alignment was required, and then anchored to bridge piles, fixing its location laterally. The steer-able trailer system was then used to move the deck section into proper alignment. The degree of difficulty related to making fine adjustments within a tolerance of $\pm \frac{3}{4}$ in. with a tug driven barge was thereby eliminated. The same method was used for the transfer of deck segments, cannibalized from the west-bound bridge. The innovative trailer system was cited by Boh planners as being the primary reason for completing the 45 day project with 16 days left on the schedule

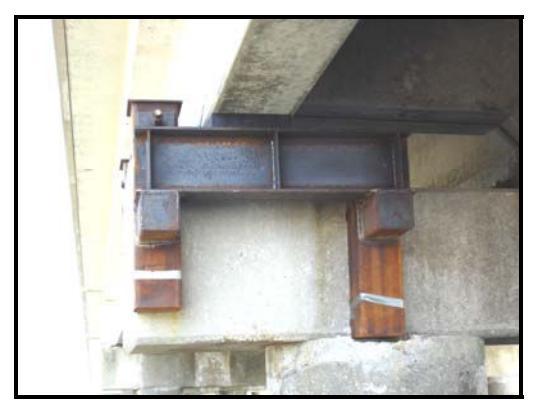
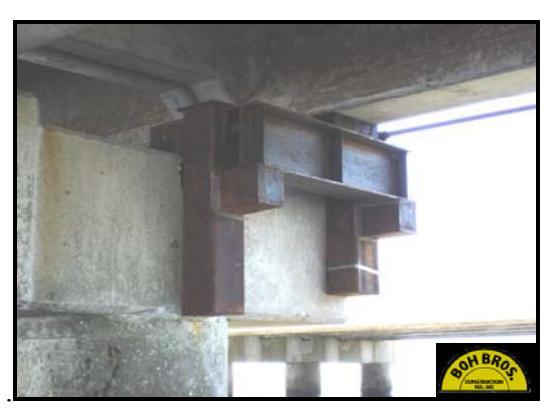
Throughout the repair projects, conditions of deck sections and pile groups were evaluated to determine future load carrying capabilities. Damage to girder ends and pile caps, resulting from anchorage breaks at bearing pads, was the most common cause of unserviceable girder and support conditions. In most cases damage was primarily confined to within 18 in. of the girder end, while the remainder of the deck and girder section remained undamaged. To create a reliable load path for the transfer of the reaction at the end of a girder to the pile cap, steel saddles were installed (Figure 9 and 10). The cap saddles provided a clear load path where the reliability of the girder or pile cap material was uncertain and prevented the need for complete replacement of many deck segments.

Figure 9: Cap Saddle

Figure 10: Cap Saddle

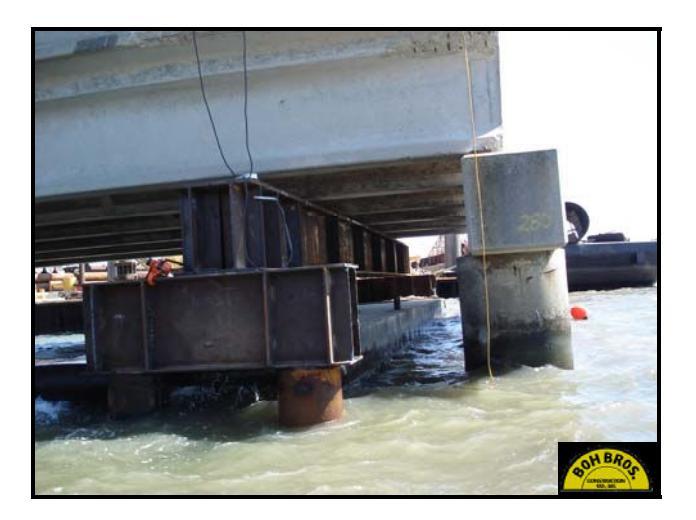
Figure 11: Auxiliary Steel Bent

In addition, several piles were damaged from the impact of decks sliding into the lake. Since it was difficult to evaluate the extent of damage to these piles, steel bents were installed to add reliability to damaged pile groups. The new bents were constructed by adding one steel support to on each side of the damaged pile group (Figure 11). The supports consisted of two round hollow steel piles on each side of the bridge span. A short transfer member was installed between piles, which supported a double steel girder passing beneath the bridge and supporting the girders. These bents were able to be constructed without removing existing pile groups or deck segments, resulting in significant time savings (Figure 12).

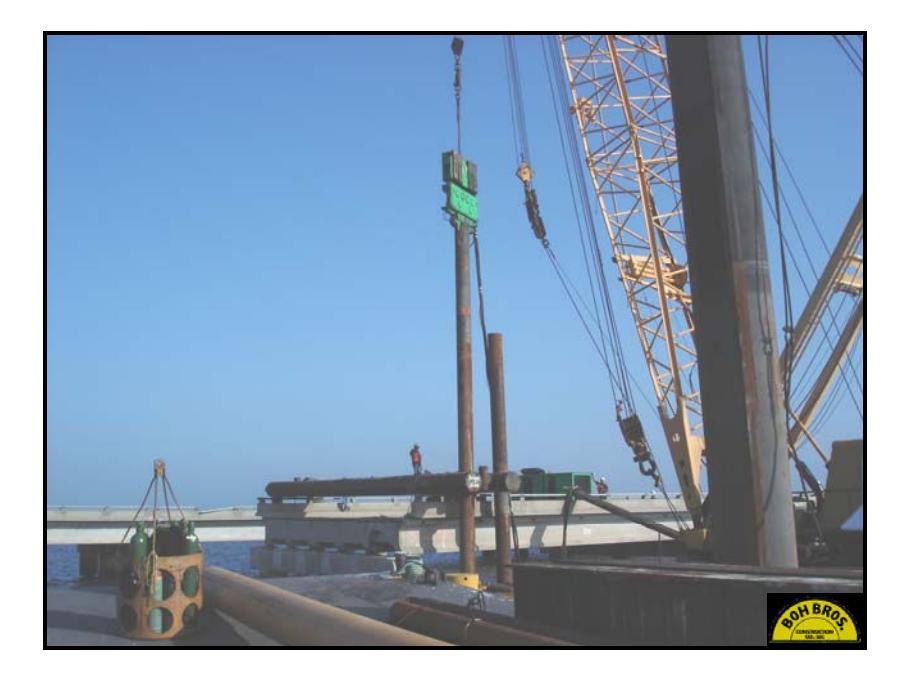
Figure 12: Pile Installation for Auxiliary Steel Bents
